CONTRACT NO. DE-AC27-01RV14136 – LOW-ACTIVITY WASTE BASEMAT COLD JOINT

Enclosed are the formal submittal of the report (Attachment 1) and the Olson Report, "Final Concrete Condition Assessment Report Southeast Foundation Slab Cold Joint Evaluation," (Attachment 2) which was previously submitted in draft.

**FINAL CONCRETE CONDITION ASSESSMENT REPORT
SOUTHEAST FOUNDATION SLAB COLD JOINT EVALUATION
LOW ACTIVITY WASTE STRUCTURE
DOE HANFORD WASTE VITRIFICATION PROJECT
HANFORD, WASHINGTON**

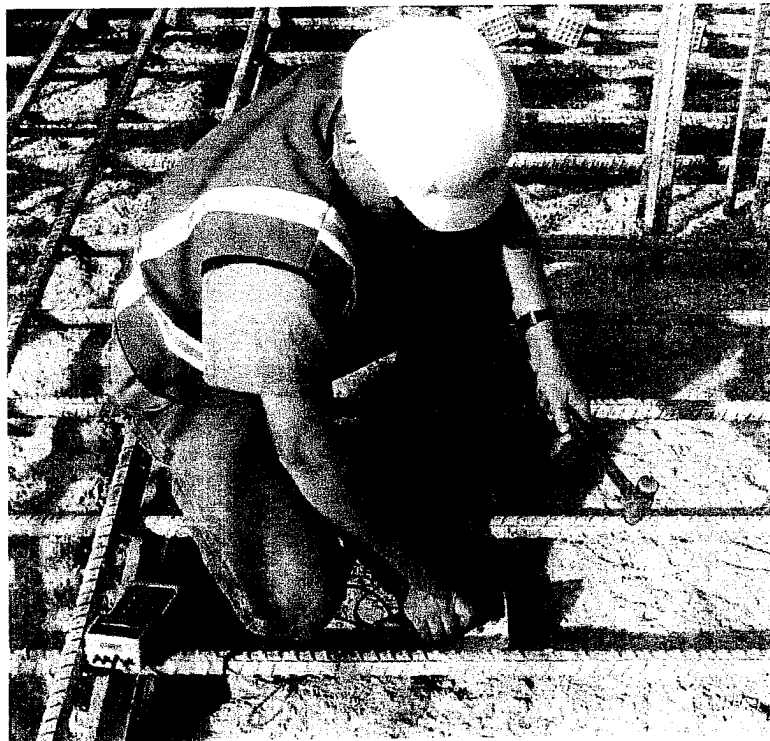
Figure 3 - CTG-1TF during IE Testing

The IE method was performed during this investigation using our Olson Instruments Concrete Thickness Gauge (Model CTG-1TF). The CTG is a nondestructive, battery powered, handheld instrument for measuring the thickness and integrity of concrete slabs, pavements, tunnel linings, walls and other plate-like structures. The IE tests performed in this investigation involved impacting the concrete slab with a small solenoid operated impactor or small hammer and identifying the reflected wave energy with a displacement transducer (Fig 3).

CTG (shown in Fig. 3) during the field NDT&E and later downloaded to a computer for post-processing. The CTG can store up to 300 records.

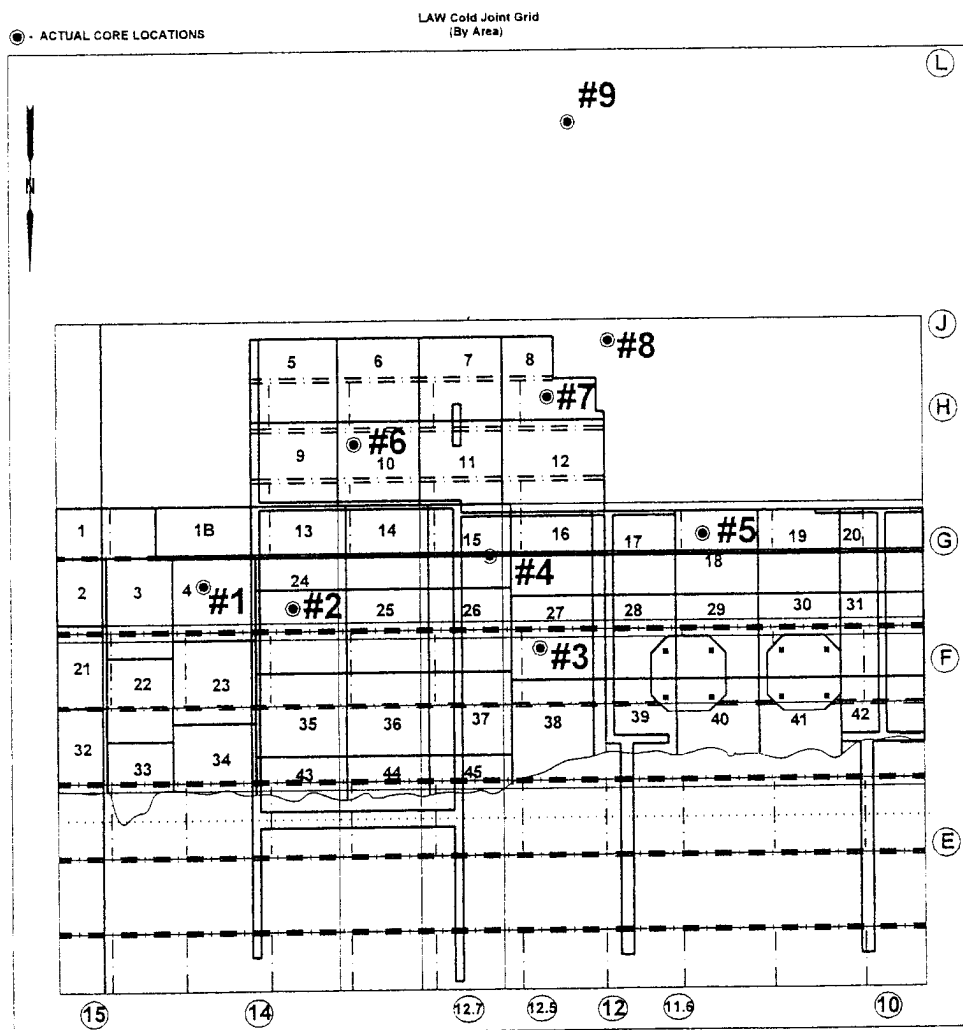
Figure 7 - Actual Core Locations

1. Core Drilling Program. A total of 9 - 3.66 inch diameter cores were drilled for BECHTEL from the slab surface to within a few inches of the bottom mat of reinforcing steel at the locations shown in Figure 7. Five of the core locations were selected in the north-central cold joint area where NDE results identified questionable quality concrete. Two cores were obtained from the apparent good quality concrete of the east and west cold joint areas. In the full 5-ft thick section area, a core was taken from near the south edge of the cold joint where concrete temperatures had increased and the final core was taken from near the south edge of the slab where concrete temperatures were below the specified 70 degree F limit. The cores were thus located from south to north to check for any degradation in compressive strength and internal thermal cracking as a result of the increasing temperature of concrete. The cores were also located to sample areas of apparent questionable quality and good quality concrete in the cold joint. As no evidence of void or honeycomb was visible below the bottom reinforcing steel along the chipped out north edge of the cold joint, the cores were not extended through the slab in order to avoid cutting the steel. The initial Impact Echo results also did not indicate the presence of significant honeycomb/void below the bottom mat of steel (where thickness echoes were obtained in cold joint areas).

of full 5 ft thickness to the thinnest cold joint section which resulted in 29 core specimens for compressive strength tests, which exceeds the most stringent ACI criteria. The samples were located to check for internal thermal cracking in full-thickness and cold joint areas and in an attempt to sample near-surface questionable quality concrete that still remained in some cold joint areas after initial chip-out and removal operations. Figure 7 below shows the 9 core locations.

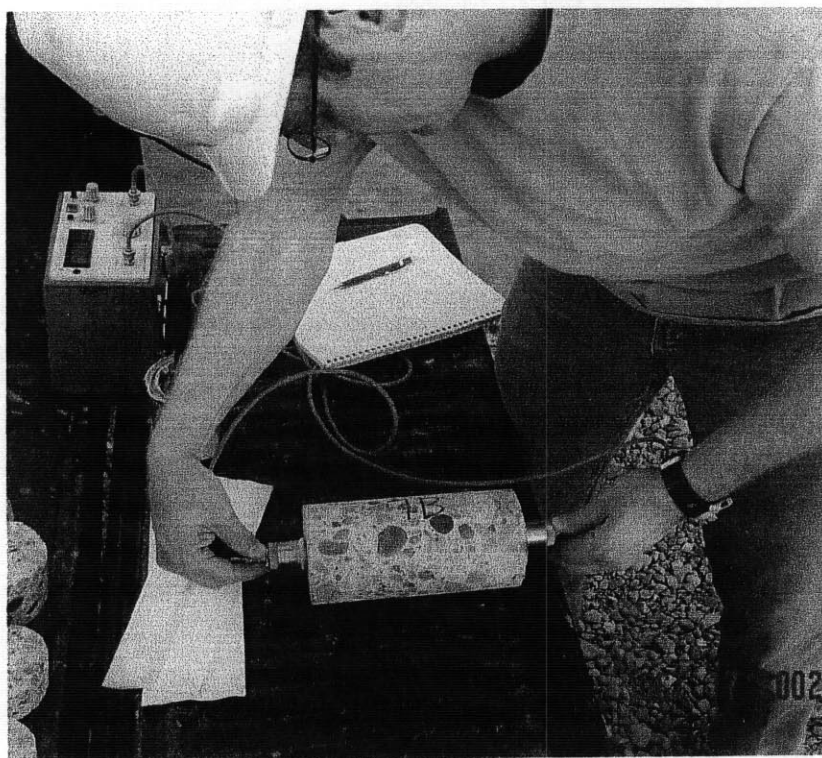
Figure 8 - Ultrasonic Pulse Velocity test performed on Core 7B

The average diameter of the core samples was 3.66 inches. The average ultrasonic pulse velocity (UPV) measured in the field was 15,000 fps, with a maximum velocity of 15,800 fps and a minimum velocity of 13,800 fps. These values are indicative of good quality concrete. The compressive strength tests were conducted per ASTM C42-99, C39-01 (see Figs. 9 and 10) and yielded an average value of 5,249 psi, with minimum and maximum values of 4,030 psi and 6,050 psi respectively. All values exceeded the minimum compressive strength requirement of 4,000 psi and met the ACI 318-5.6.5 criteria. The average unit weight calculated from the core samples is 152.1 pcf, with minimum and maximum values of 149.5 pcf and 155.3 pcf respectively which are typical of normally consolidated concrete. Table I summarizes the results of the laboratory test program. Photographs of each full length core recovered can be found in Appendix B. Table II summarizes the core log, which states the observed conditions of the cores before testing.

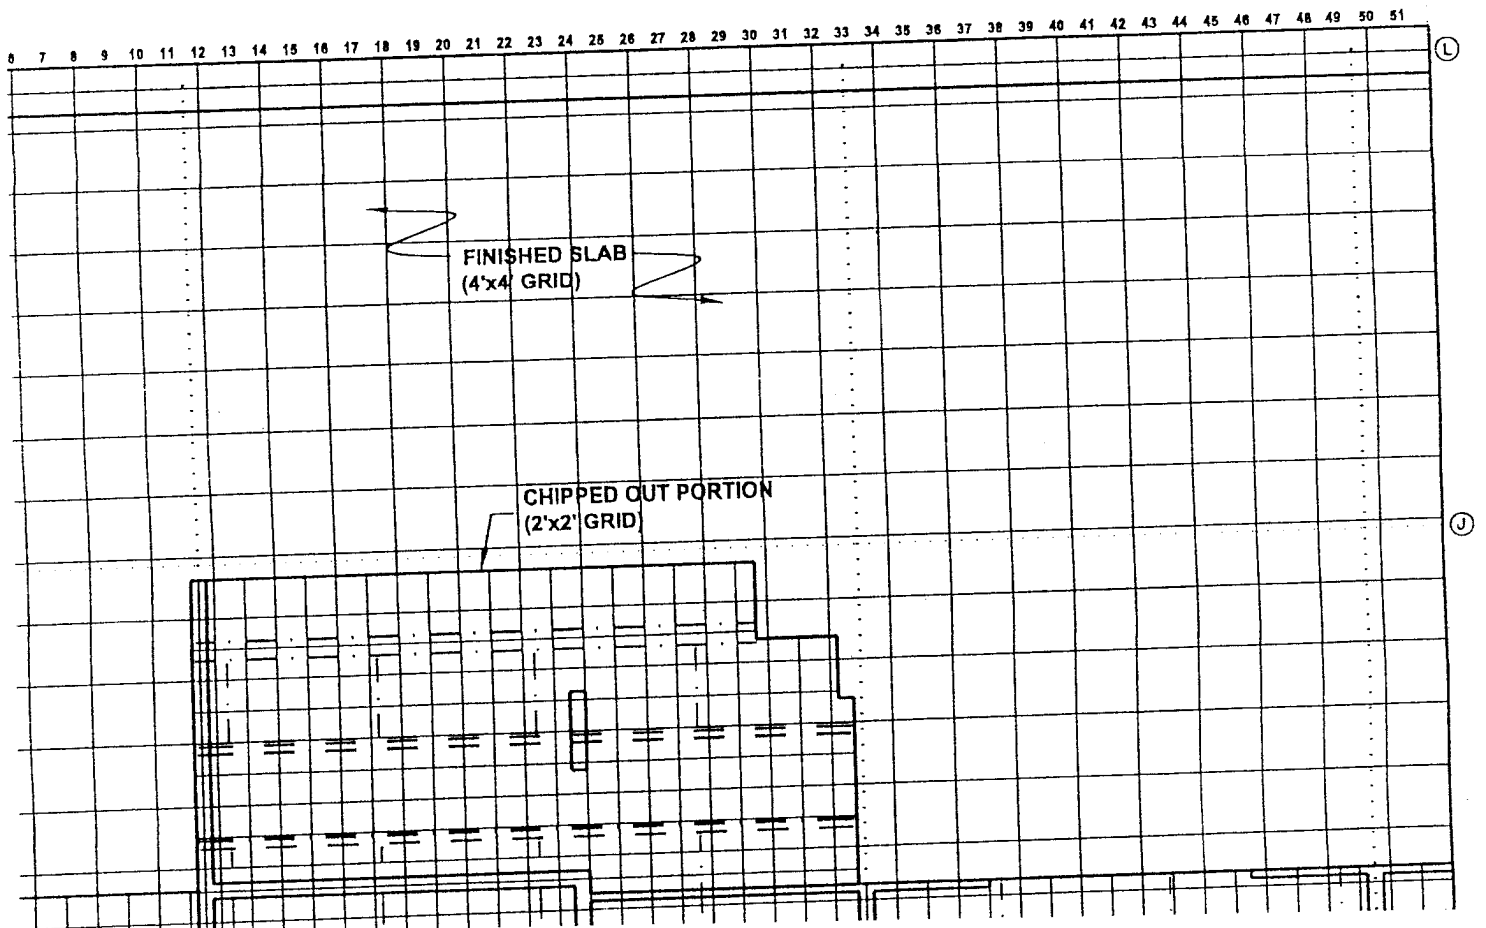
Table IA
IE Test Results

Impact Echo tests were conducted at 944 locations throughout the slab. Each test point was assigned a grid name, based on either a 4'x4' or 2'x2' grid. The layout of the grid can be found in Fig.1A in Appendix A. The results at each IE test are presented in Table IA in Appendix A. Table IA includes the test zone (grid location), measured and expected thickness, the percent error, and the pass/fail rating. All test points received a pass rating. The mean of the totaled measured values equaled 60.17 inches with a standard deviation of 2 inches. The maximum and minimum values were 66 and 54 inches, respectively.
